Recovering Full Repair Costs of INDOT Infrastructure Damaged by Motor Vehicle Crashes

Grant D. Farnsworth

RECOVERING FULL REPAIR COSTS OF INDOT INFRASTRUCTURE DAMAGED BY MOTOR VEHICLE CRASHES

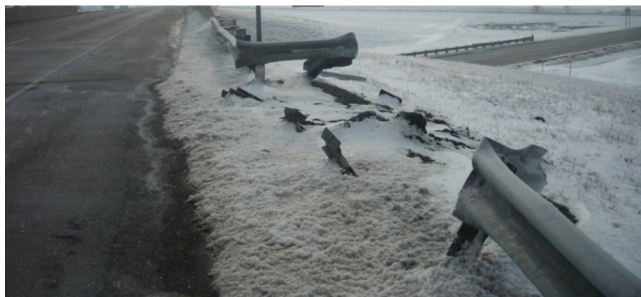
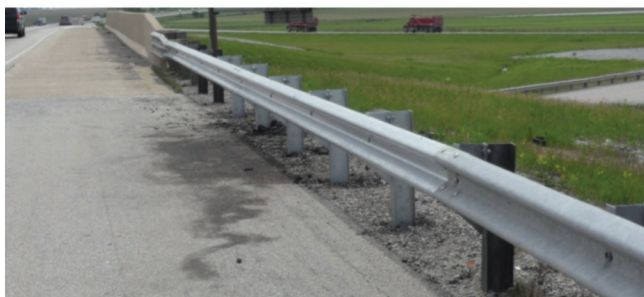
Figure 1. Crash site on I-65 adjacent to mile marker 193.4 with approximately \$1,600 in direct repair costs. Top: before repair. Bottom: after repair.

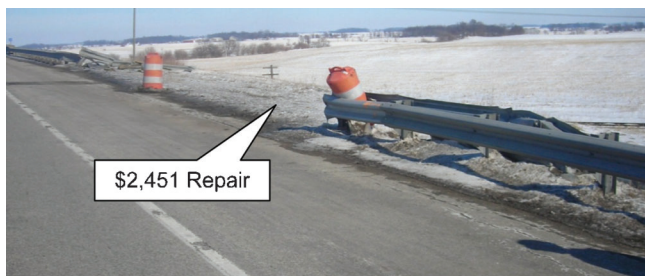
Figure 1.1: Example of damage to state property – guardrail requiring \$2,451 in repair costs.

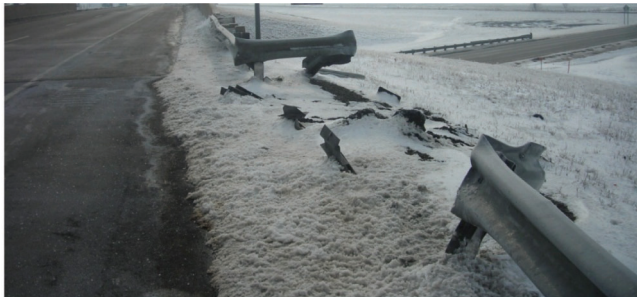
a) Crash site before repair

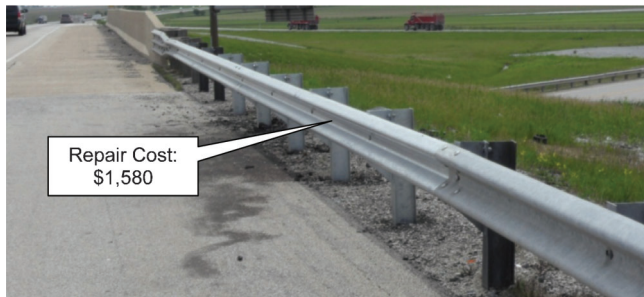
b) Crash site after repair

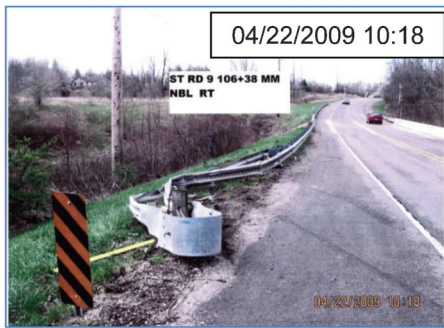
a) Crash damage before repair

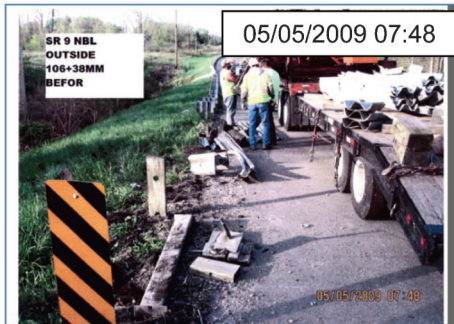
b) Repair Activity showing labor and equipment

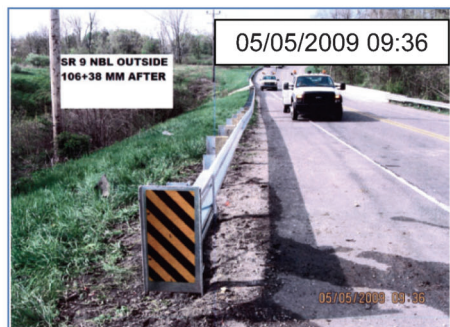
c) Repaired crash attenuator

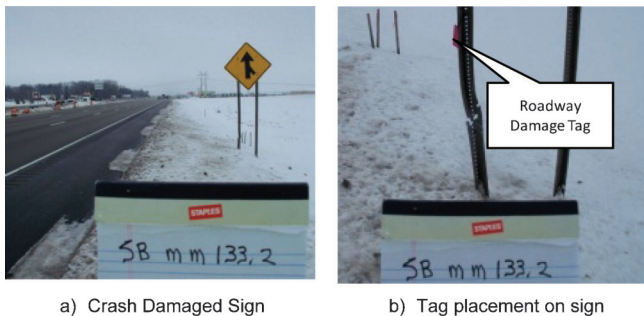
Figure 5.5: February 1st, 2011 damage at southbound I-65, MM 133.2 tagged by ISP Major Melville; Photos Courtesy of Dan Rogers

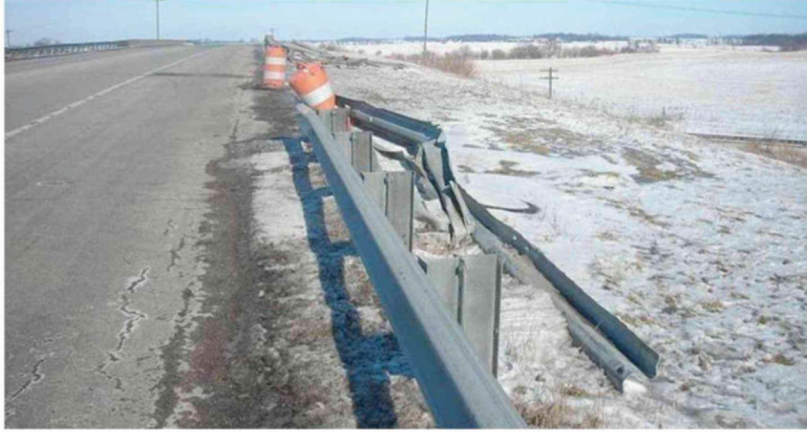
Figure 1: US231 SB; East Side: MM: ~185.5; Damaged Guardrail Posts; Photo Facing North

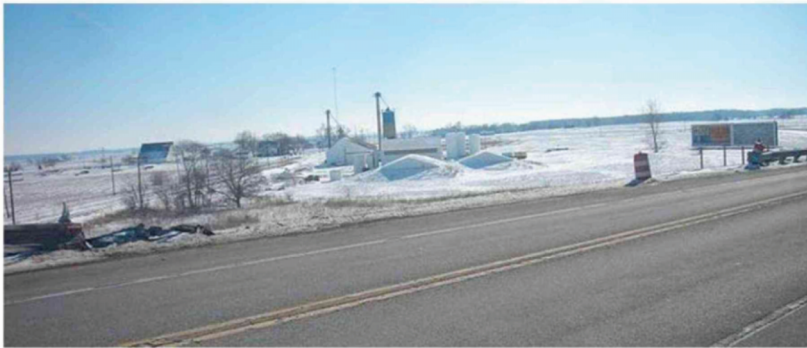
Figure 2: US231 SB; East Side: MM: ~185.5; Damaged Guardrail; Photo Facing Southeast

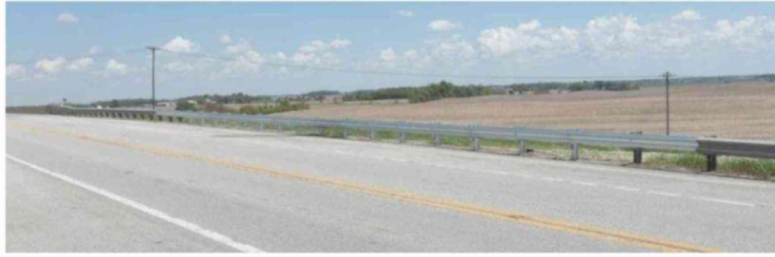
Figure 3: US231 SB; East Side: MM: ~185.5; Repaired Guardrail; Photo Facing East

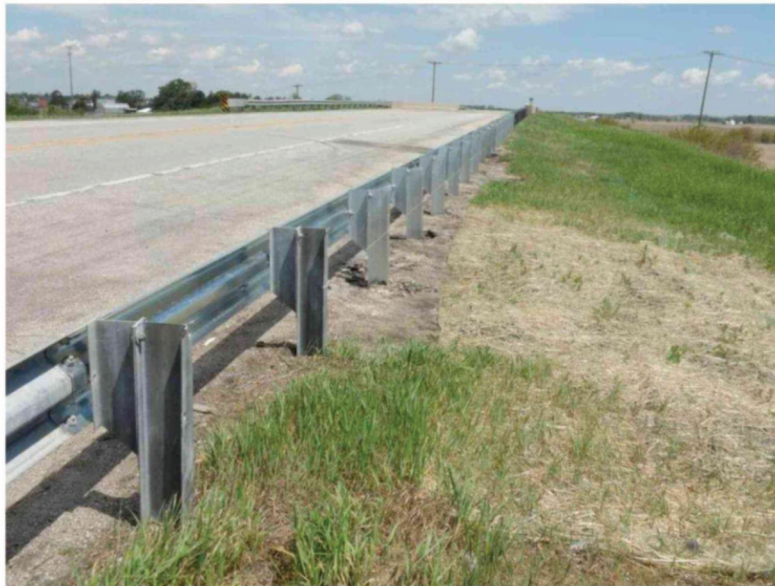
Figure 4: US231 SB; East Side: MM: ~185.5; Repaired Guardrail Posts and Sod; Photo Facing North

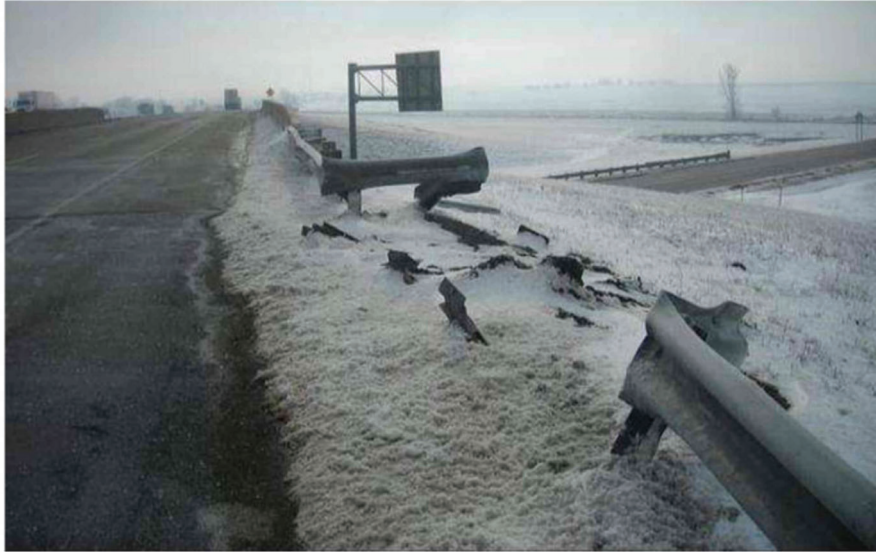
Figure 1: I65 SB; West Side; MM: ~193.4; Damage to Guardrail; Photo Facing South

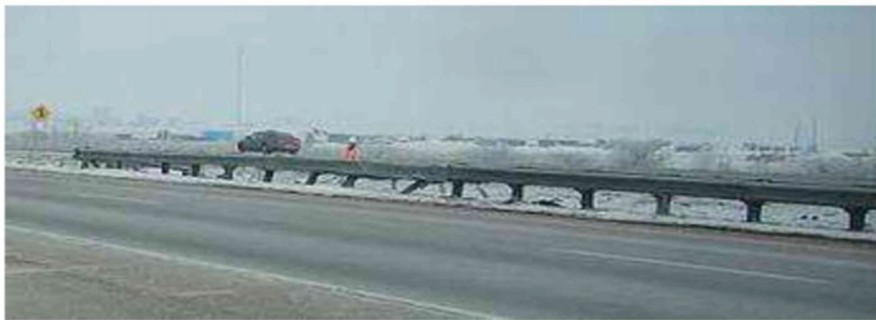
Figure 2: I65 SB; East Side; MM: ~193.4; Damage to Guardrail (Another Crash Hit Attenuator); Photo Facing East

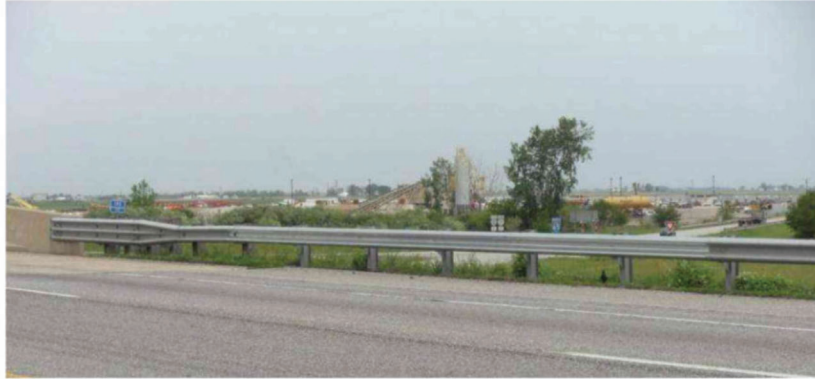
Figure 3: I65 SB; West Side; MM: ~193.4; Repair of 2nd Guardrail Hit; Photo Facing West

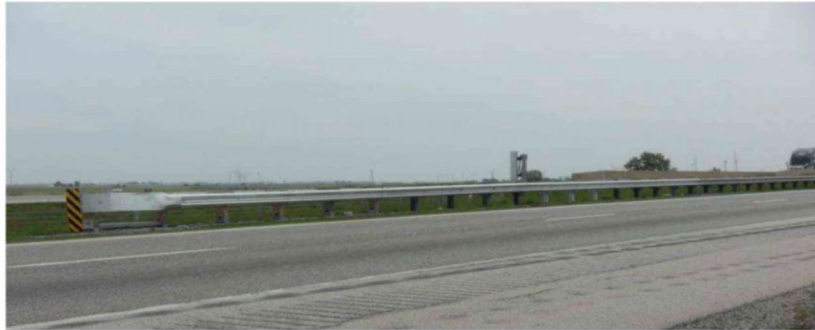
Figure 4: I65 SB; East Side; MM: ~193.4; Repair of 1st Guardrail Hit; Photo Facing Southeast

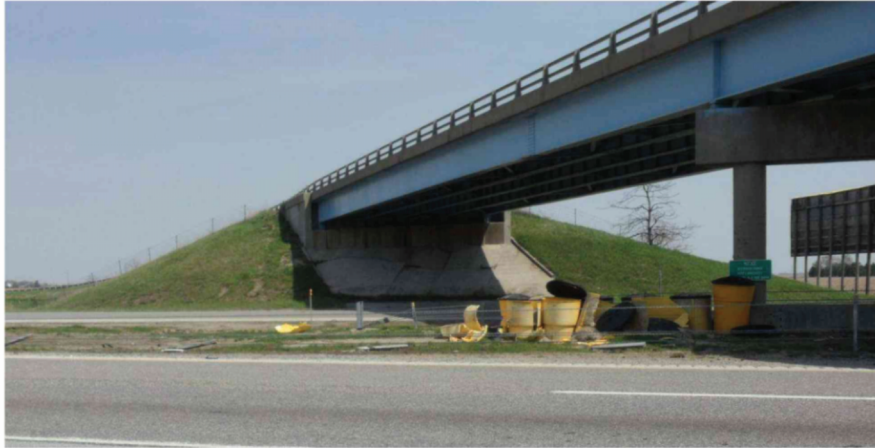
Figure 1: I65 SB; East side; MM: ~197.4; Damaged Crash Barrels; Photo Facing East

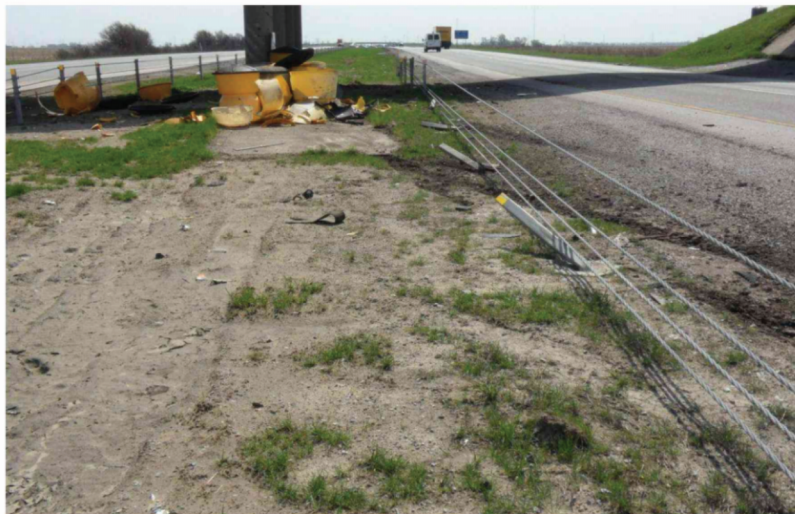
Figure 2: I65 SB; East side; MM: ~197.4; Damaged Cable-Median Barrier; Photo Facing South

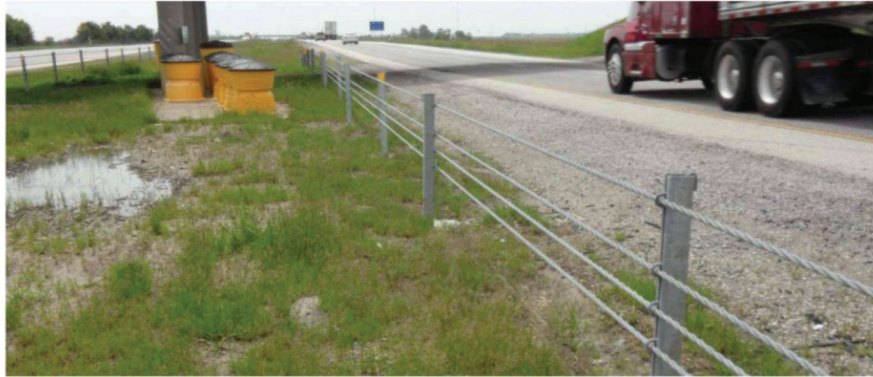
Figure 3: I65 SB; East side; MM: ~197.4; Repaired Cable-Median Barrier; Photo Facing South

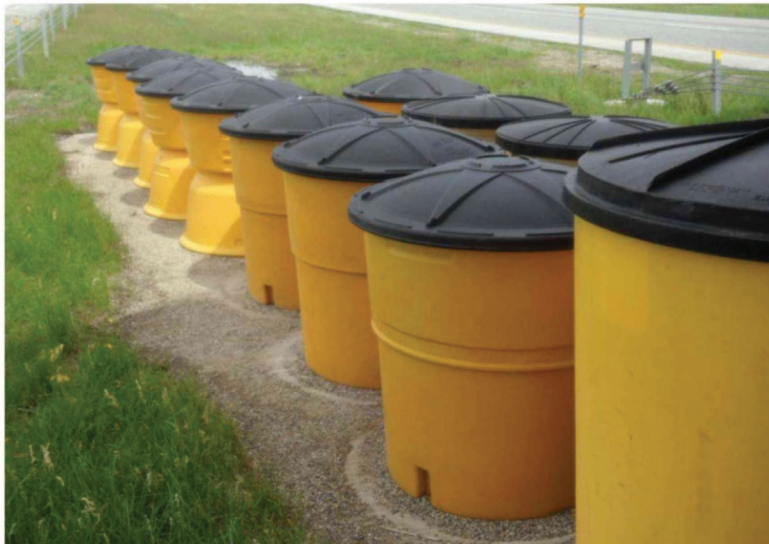
Figure 4: I65 SB; East side; MM: ~197.4; Repaired Crash Barrels; Photo Facing North

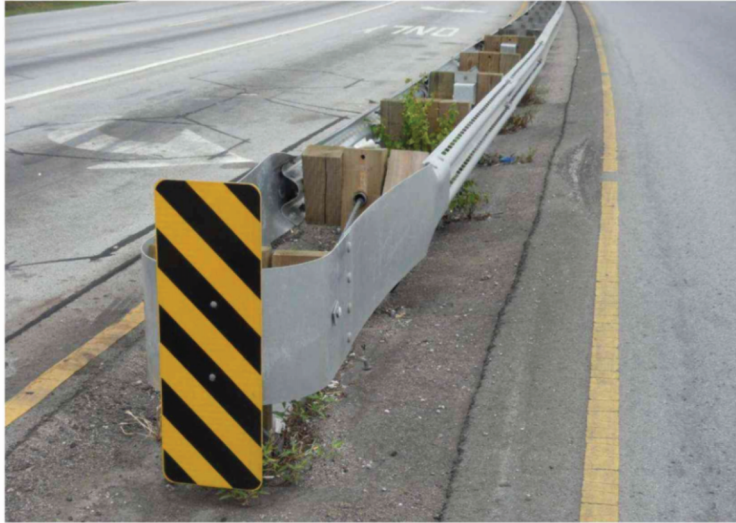
Figure 1: SR135 NB; West side; At Landmark Ave Intersection; Repaired Crash Attenuator; Photo Facing North

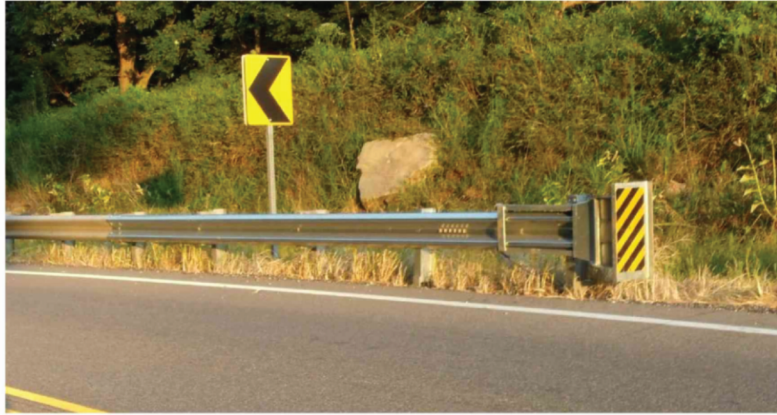
Figure 1: SR56 EB; South side; Around NE Dubois; Repaired Crash Attenuator; Photo Facing South
